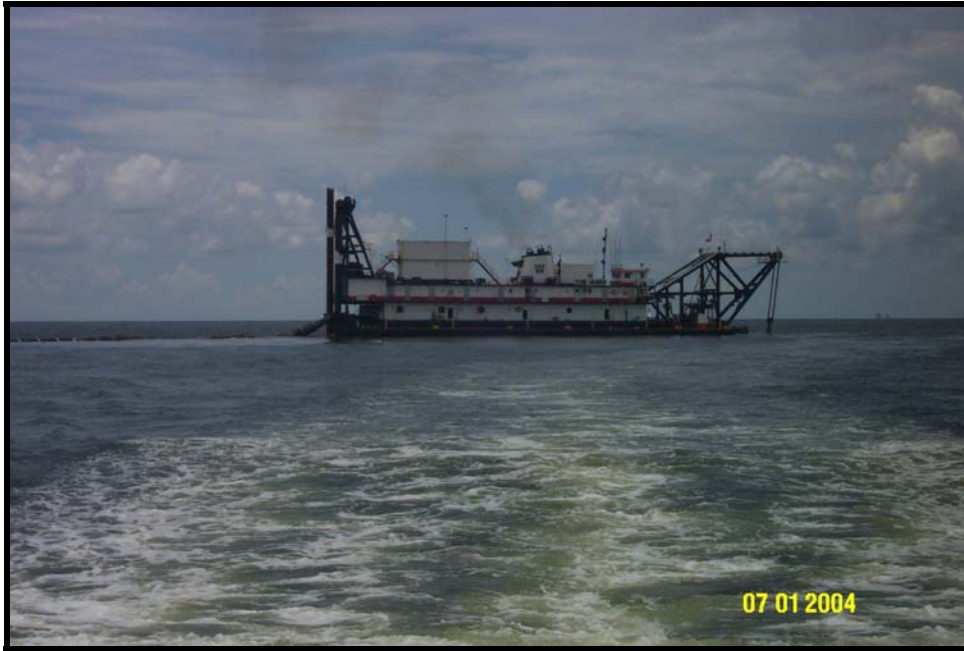
Photo 1. *View of dredge Tom James within Little Pass borrow area*

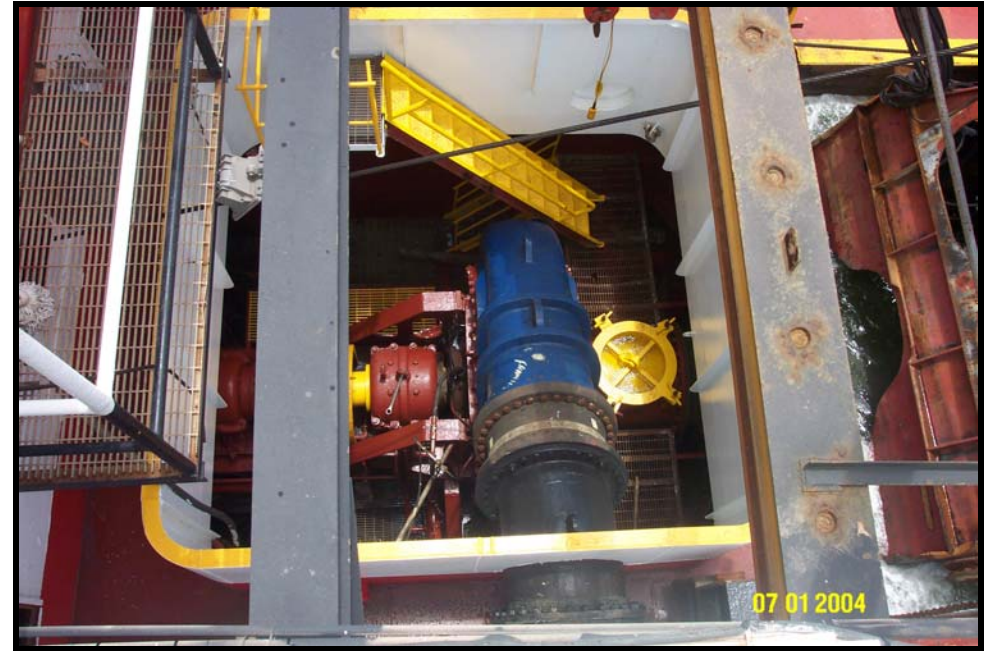
Photo 3. *View of main dredge pump (centrifugal) on the Tom James dredge*

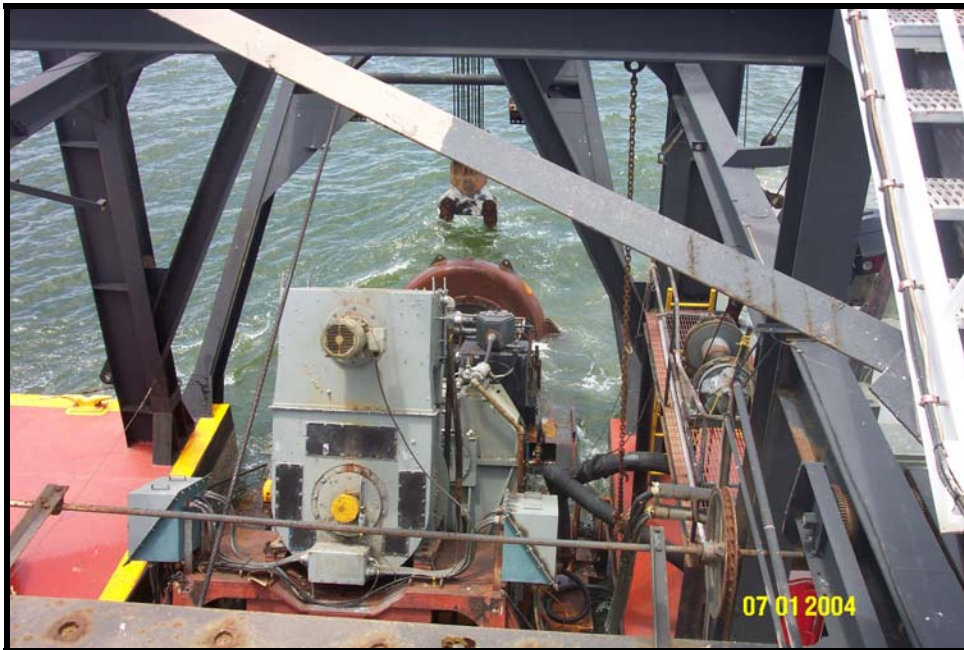
Photo 2. *View of submerged cutter head from aboard Tom James*

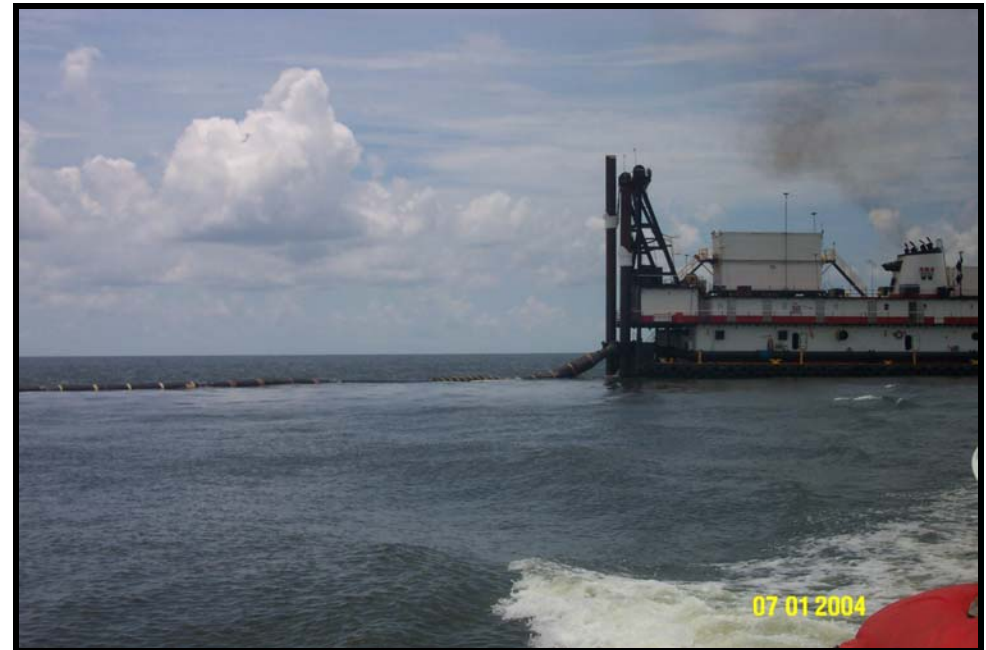
Photo 4. *View of floating discharge pipe*

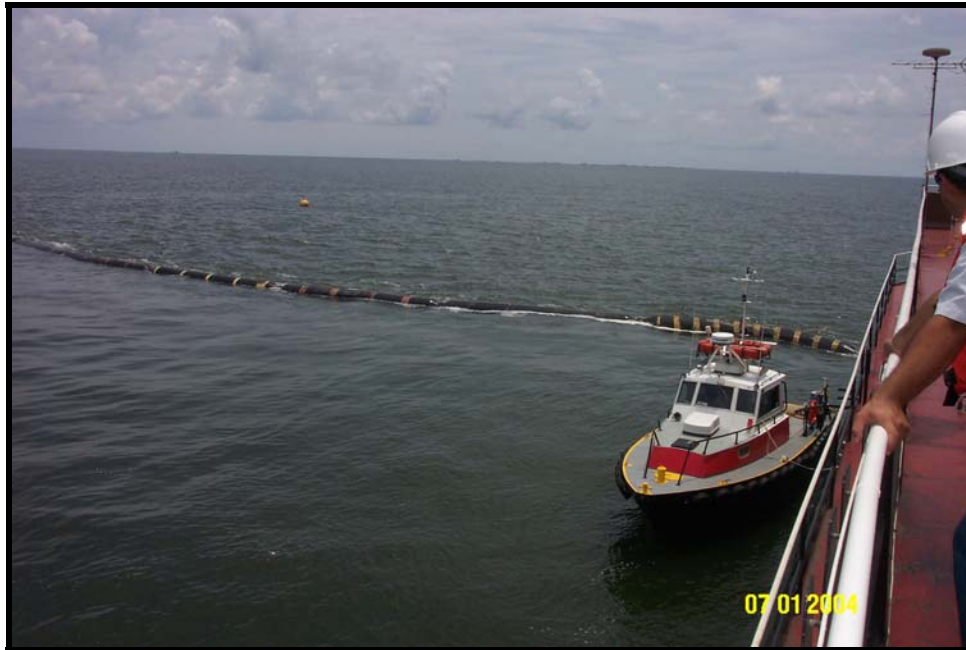
Photo 5. View of floating discharge pipe from aboard Tom James

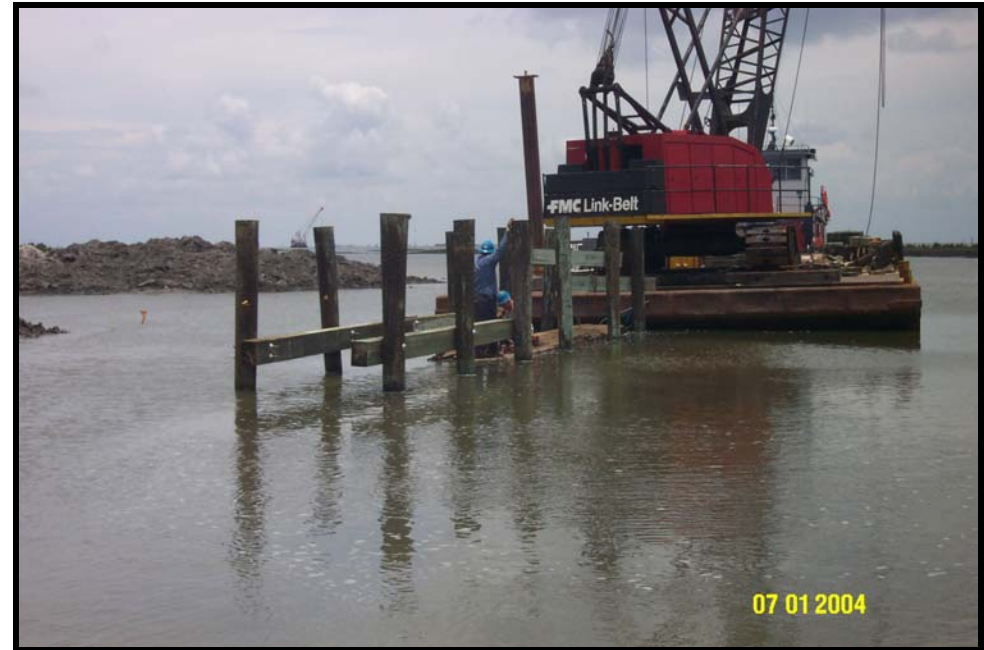
Photo 7. Timber dock construction at end of access channel, looking north towards bay

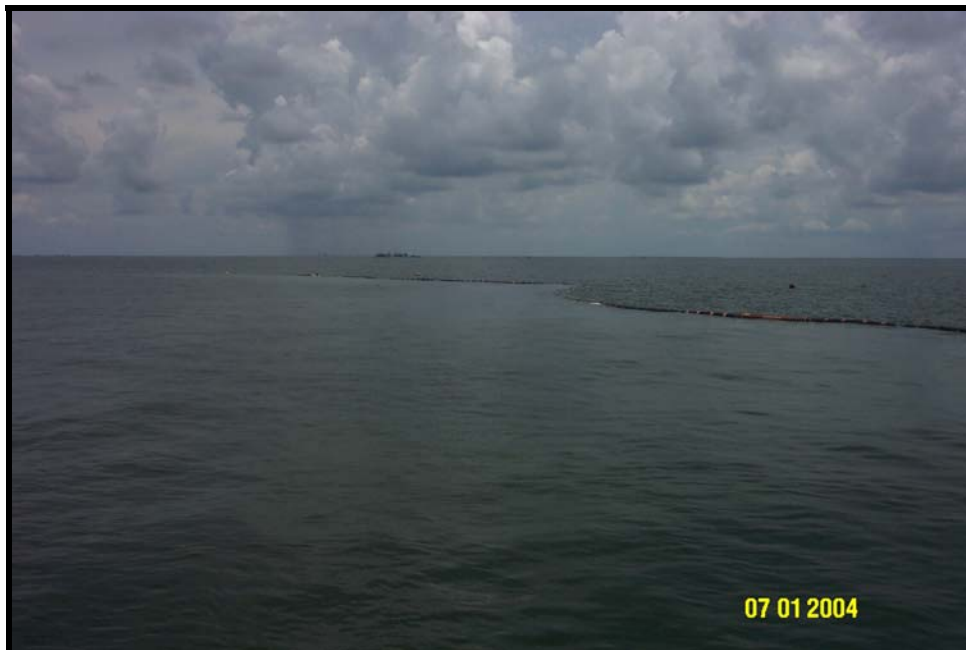
Photo 6. View of end of floating and beginning of submerged (marked by buoys) discharge pipe to Timbalier Island

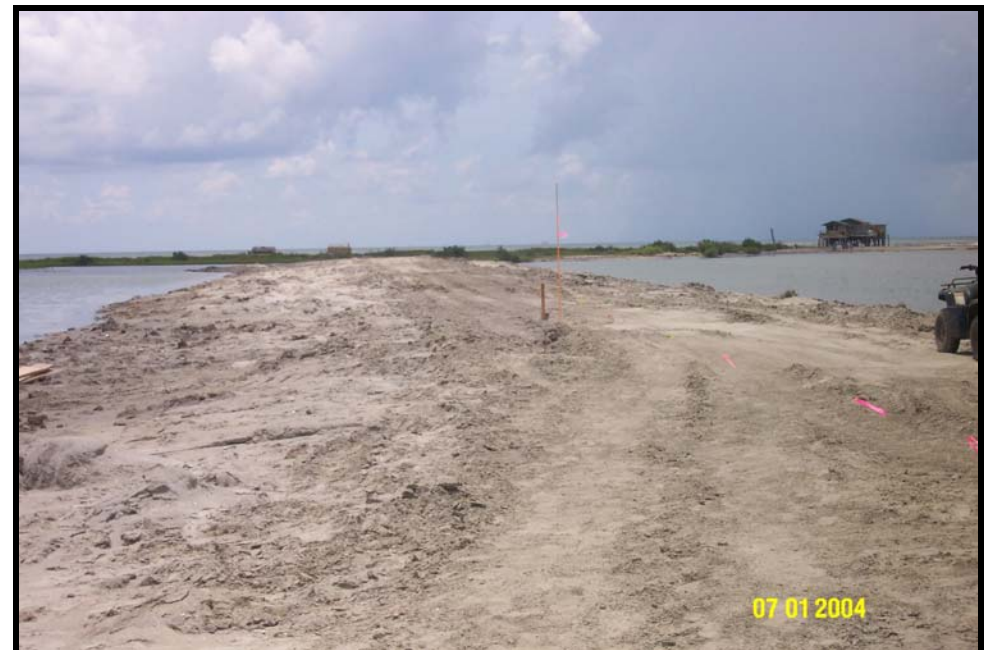
Photo 8. Access berm at appx. Sta. 170+00, looking south

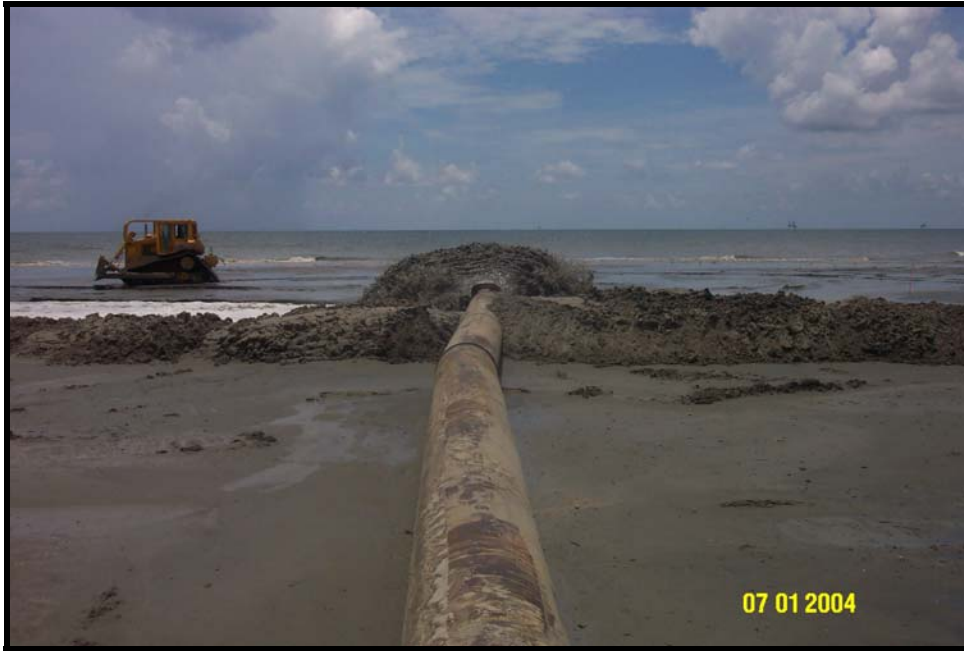
Photo 9. *Pumping beach fill material (discharge pipe at Sta. 201+50), looking southwest*

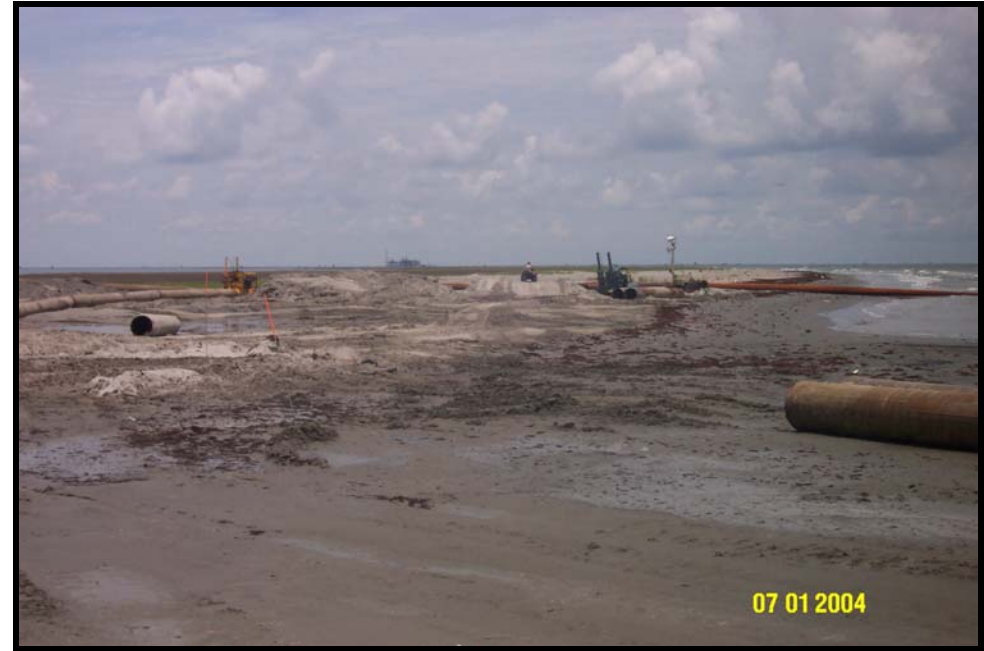
Photo 11. *View of Gulf discharge pipe and shore pipe at east end of project, looking east*

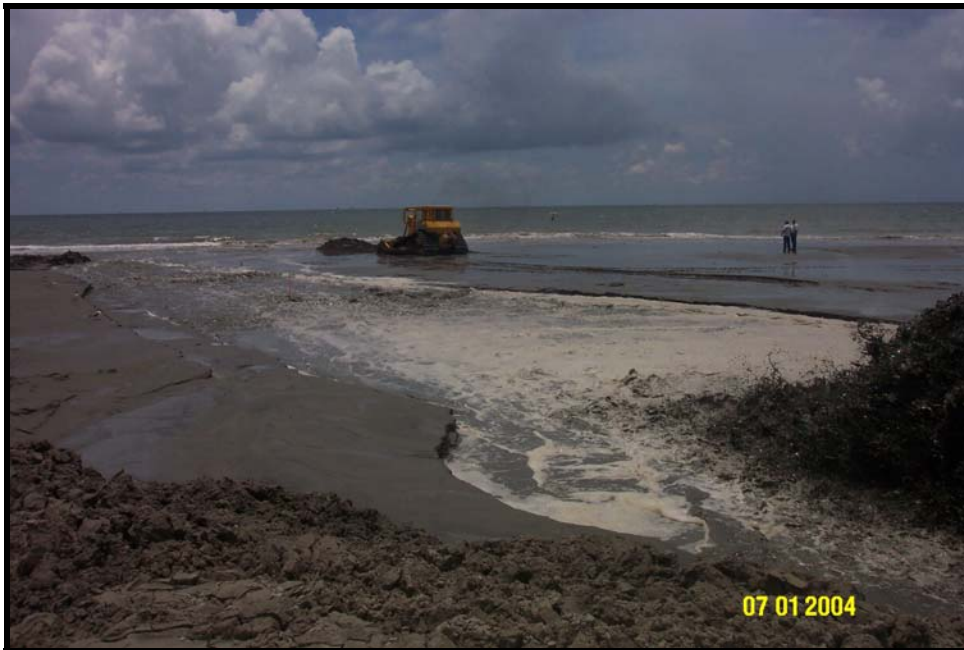
Photo 10. *Pumping beach fill material (discharge pipe at Sta. 201+50), looking southwest*

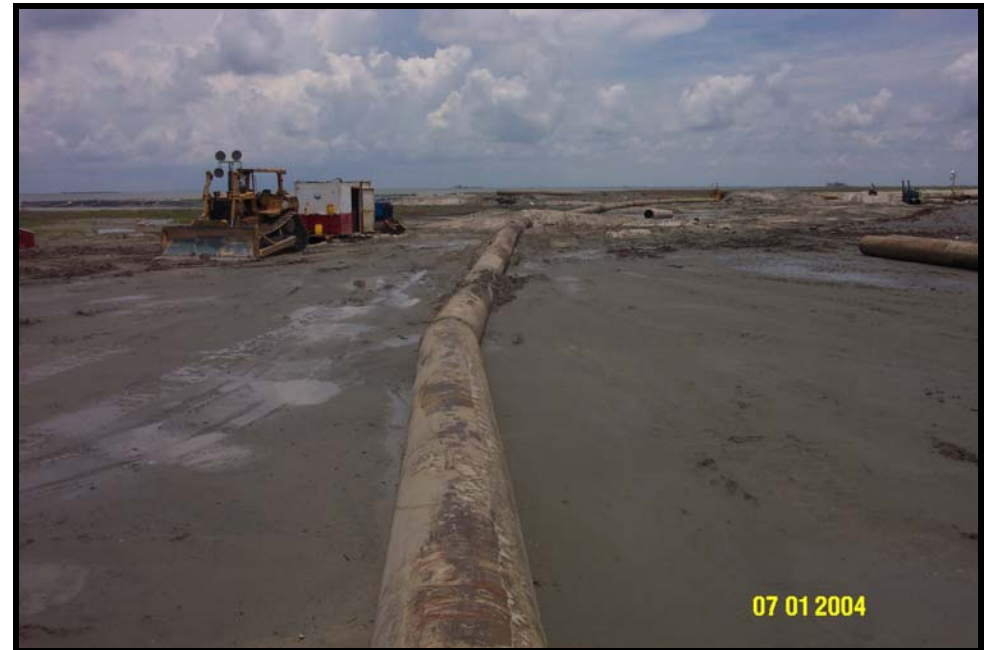
Photo 12. *View of shore pipe at east end of project, looking east from Sta. 202+00*

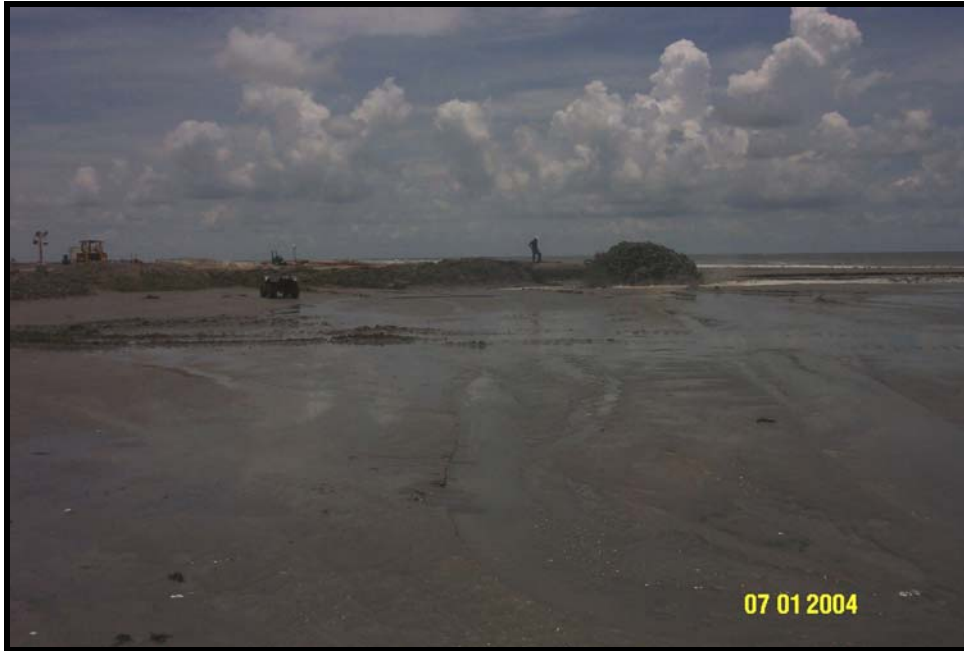
Photo 13. *Pumping beach fill material, view of discharge pipe at Sta. 201+50, looking east*

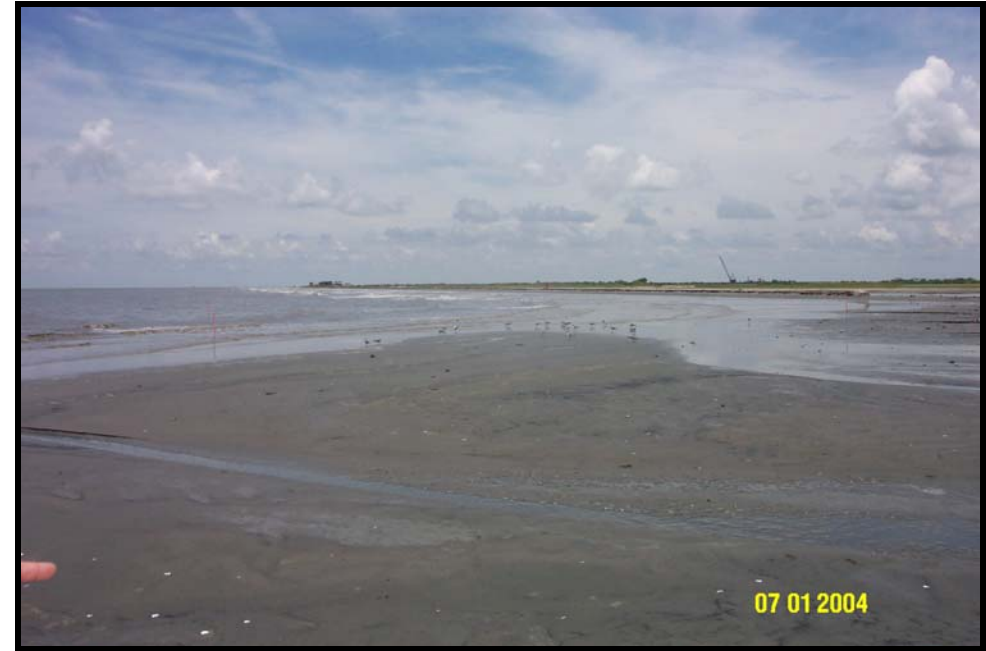
Photo 15. *View of Timbalier shoreline and newly placed beach fill (foreground), looking west standing at appx. Sta. 200+50 on beach fill*

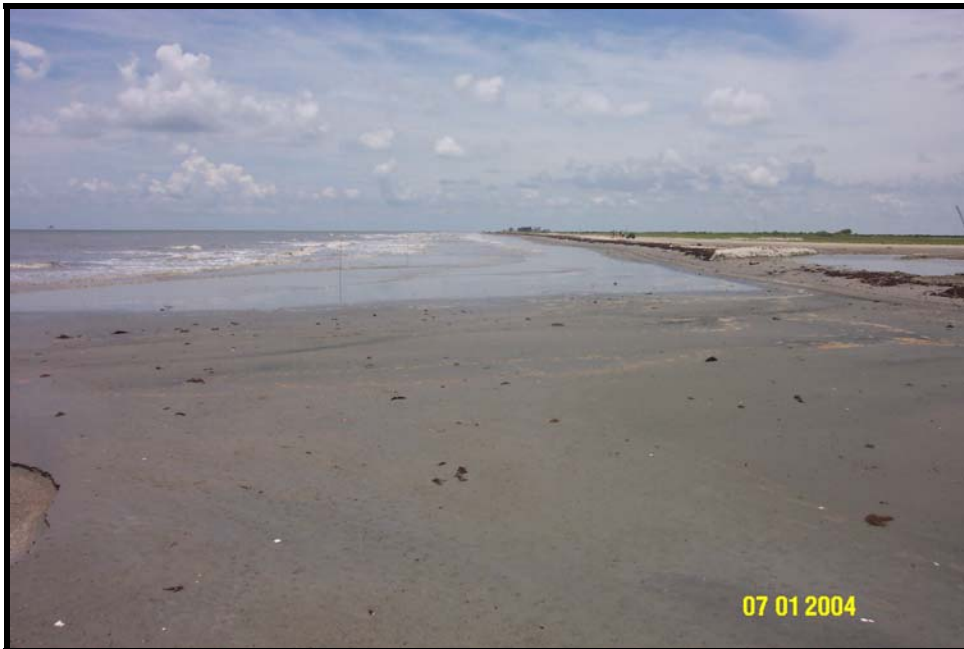
Photo 14. *View of Timbalier shoreline and newly placed beach fill (foreground), looking west standing at appx. Sta. 200+50 on beach fill*

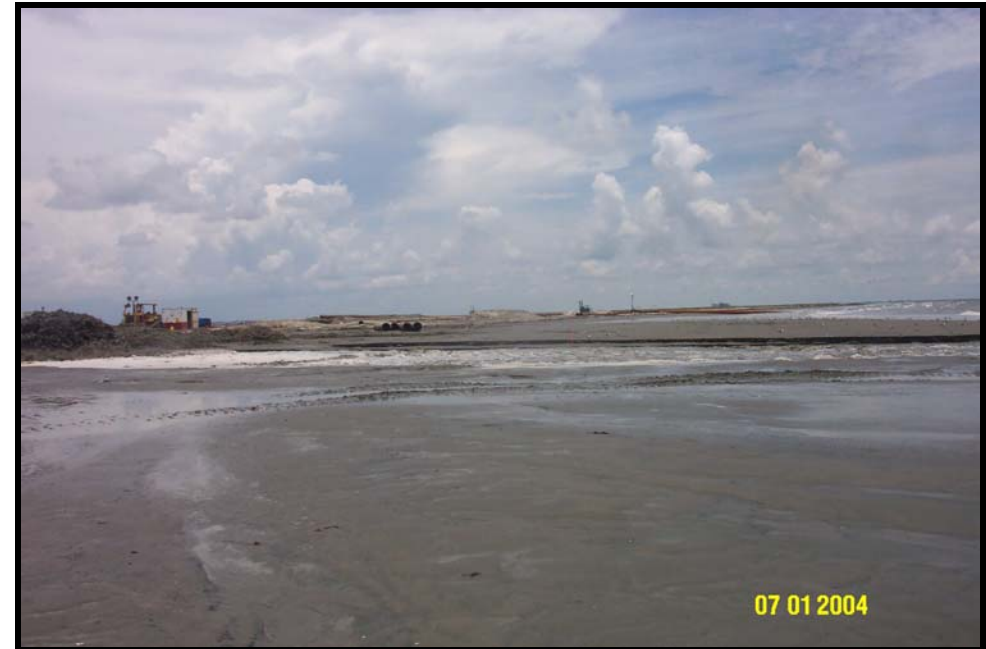
Photo 16. *View of newly placed beach fill, looking east standing at appx. Sta. 200+50*

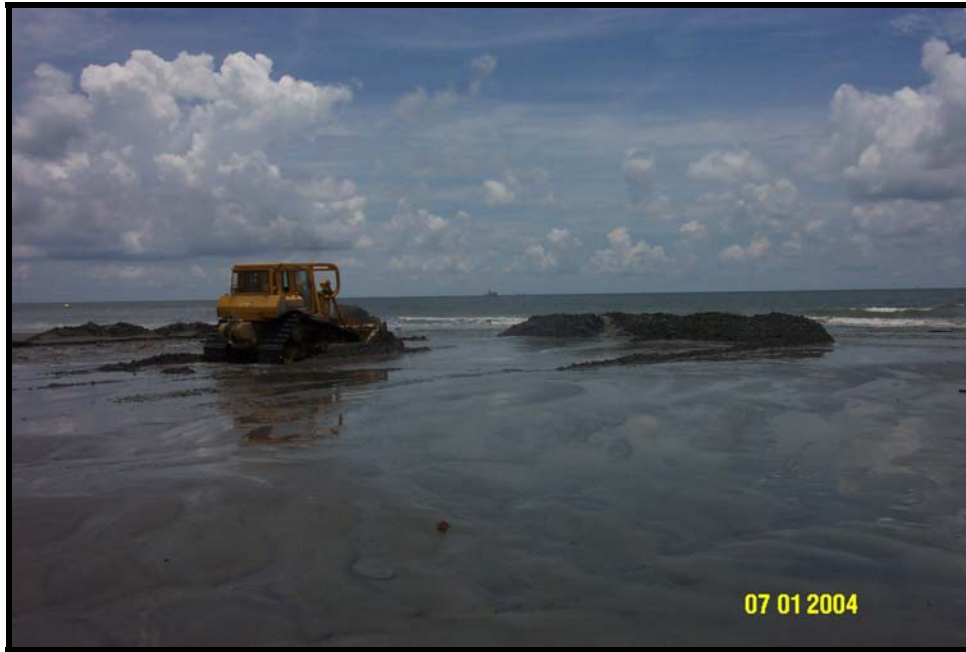
Photo 17. *Bulldozer moving newly placed beach fill material at Sta. 201+50*

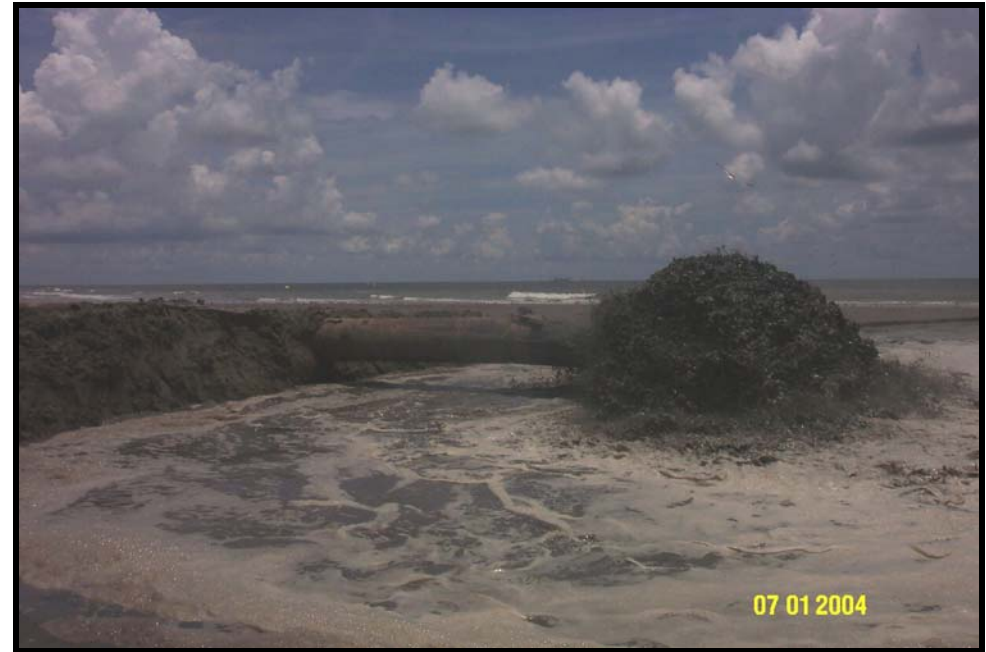
Photo 19. *Pumping beach fill material at Sta. 201+50, looking southeast*

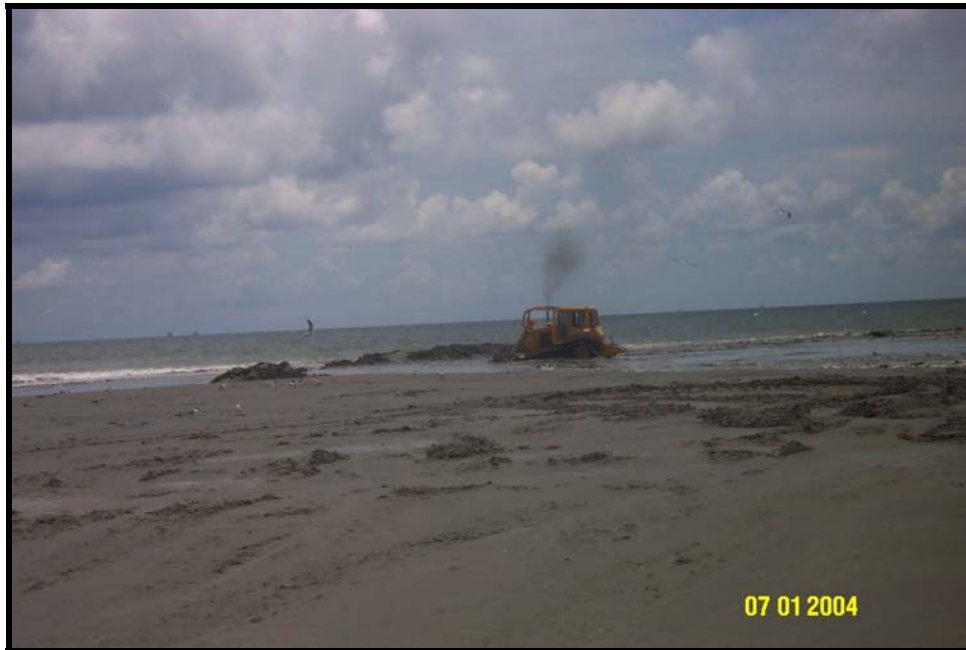
Photo 18. *Bulldozer moving newly placed beach fill material at Sta. 201+50*

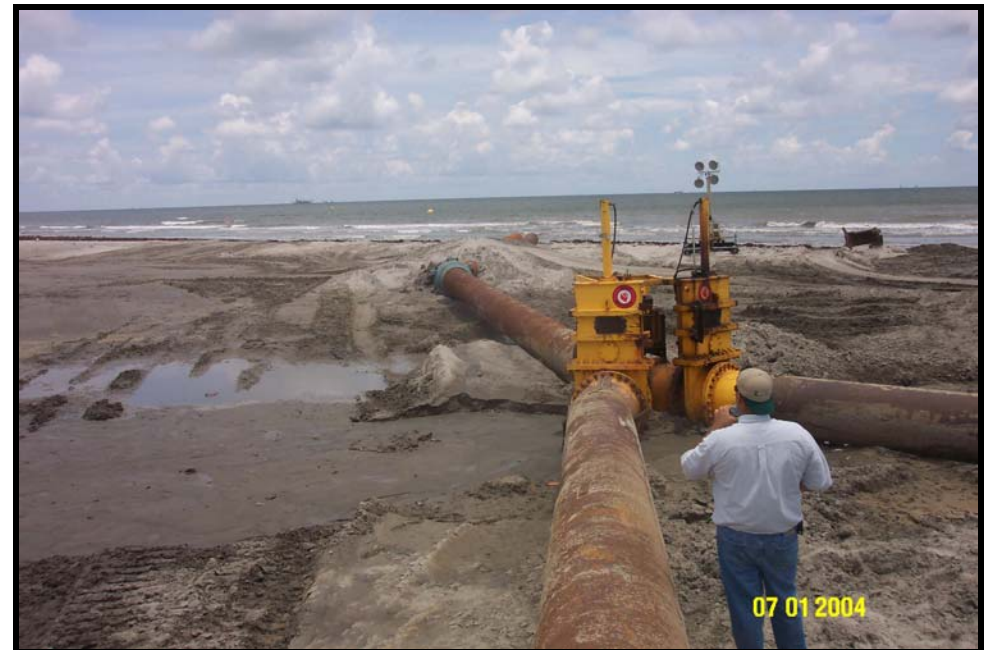
Photo 20. *View of shore pipe y-valve at connection to Gulf discharge pipe at east end of project (Sta. 206+00)*

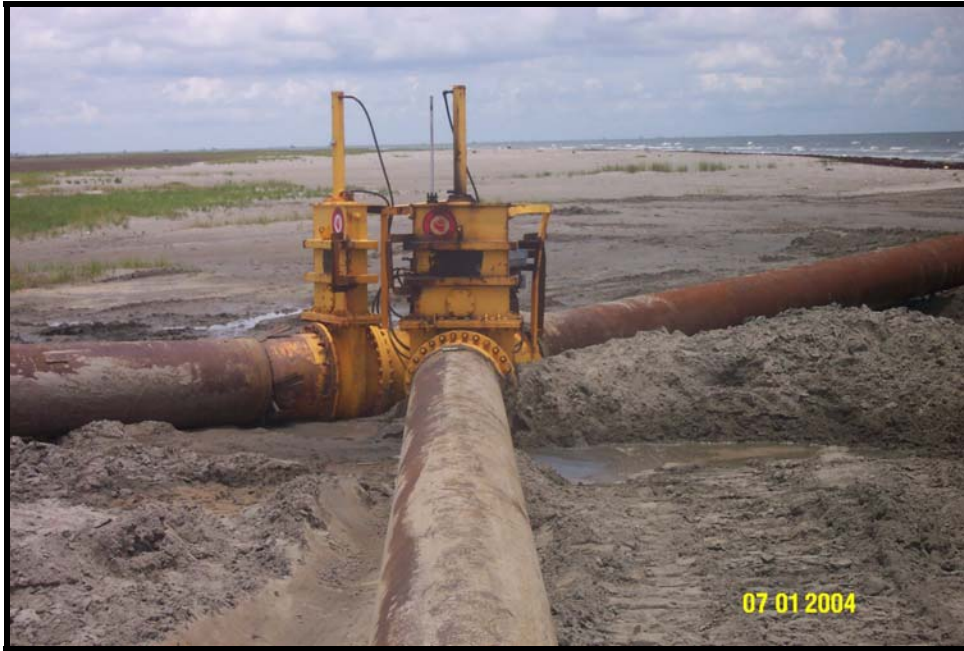
Photo 21. View of shore pipe y-valve at connection to Gulf discharge pipe at east end of project (Sta. 206+00)

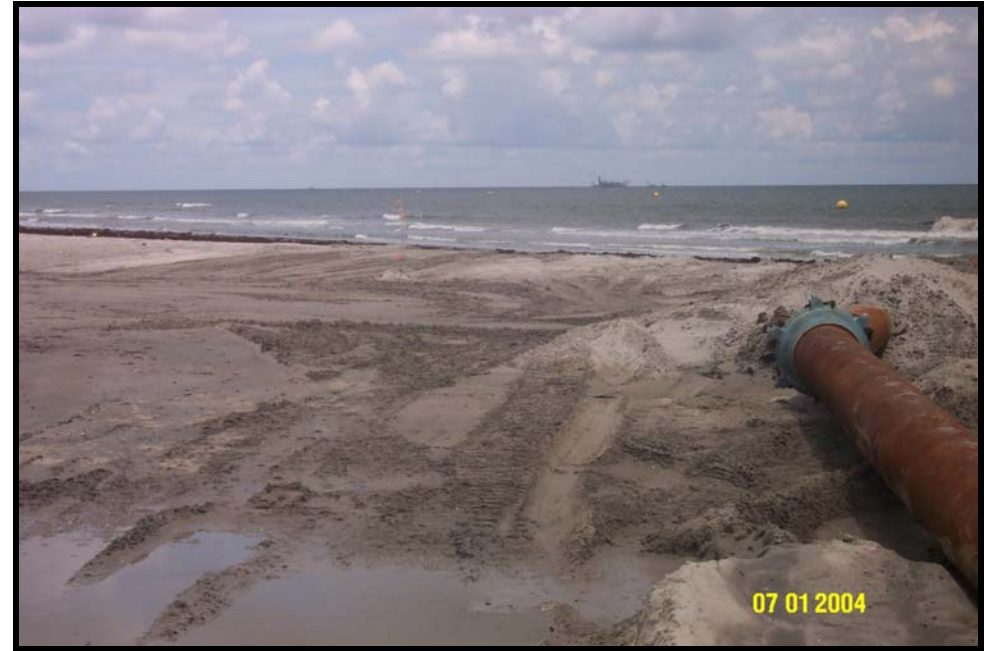
Photo 23. View of shore pipe connection to Gulf discharge pipe at east end of project

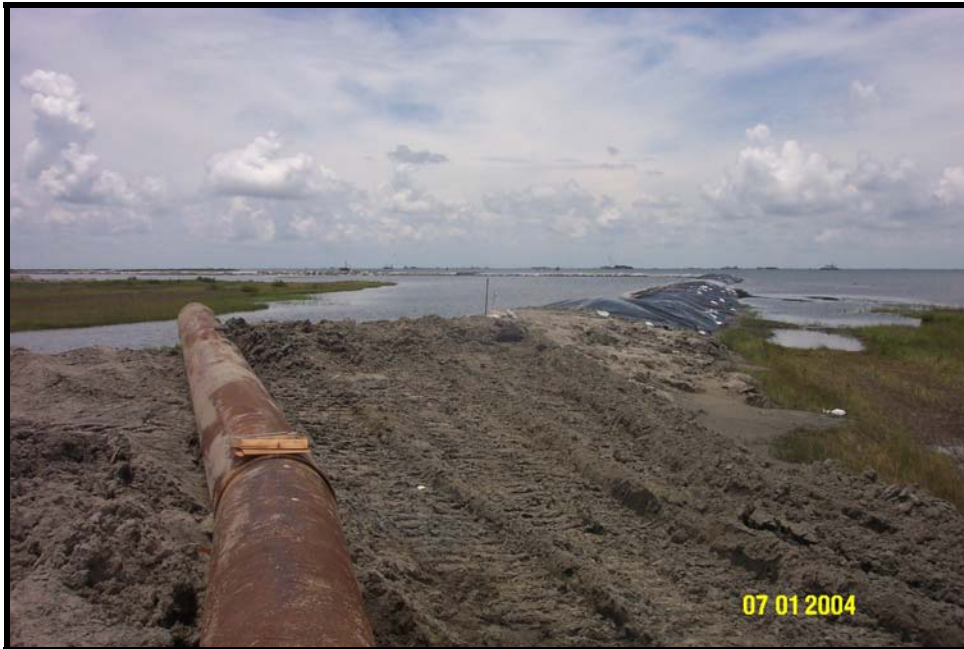
Photo 22. View of side dike and back dike at east end of project (Sta. 206+00), looking north

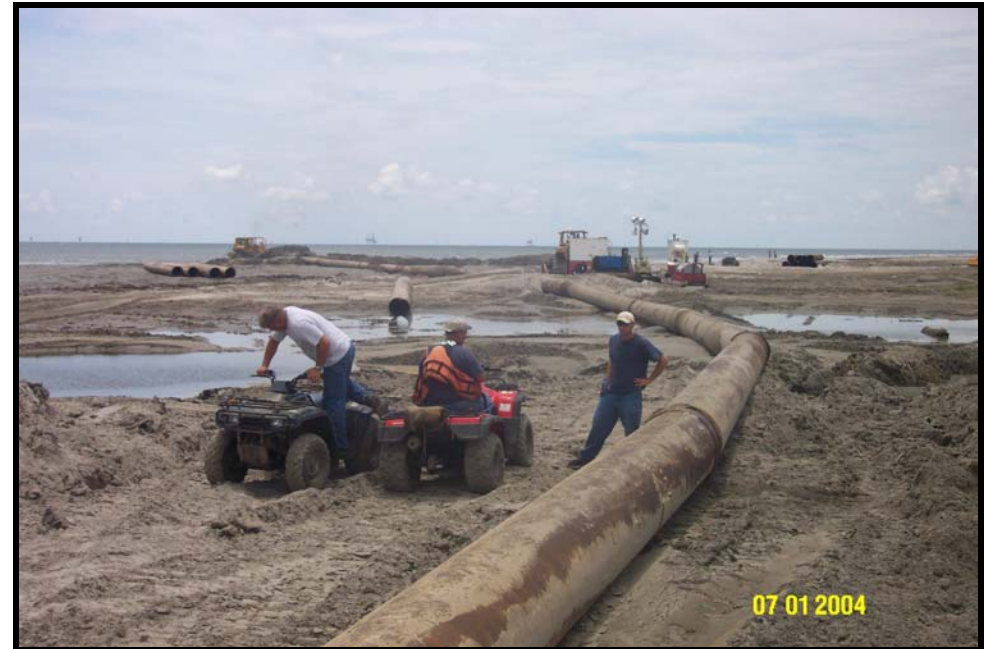
Photo 24. View of shore pipe looking southwest from appx. Sta. 205+50

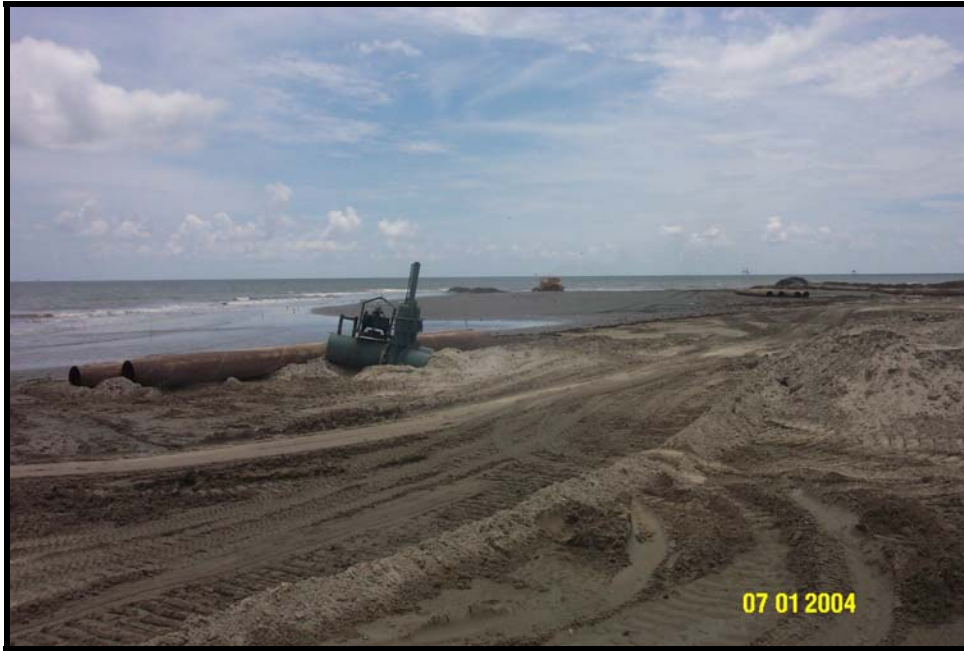
Photo 25. View of newly placed beach fill, looking west from appx. Sta. 205+50

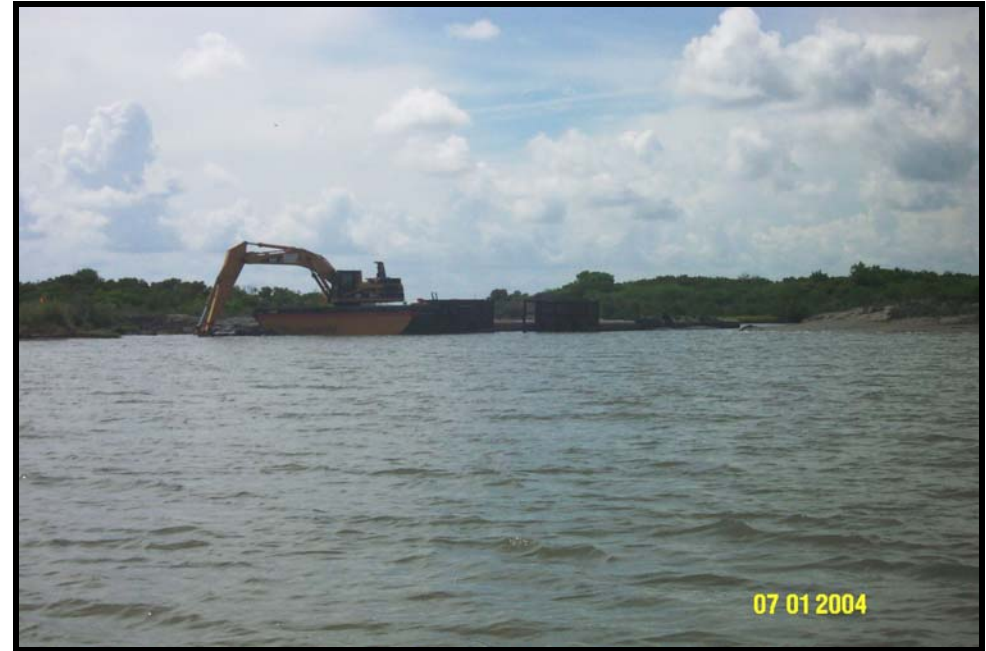
Photo 27. View of overflow weir boxes and construction of back dike at appx. Sta. 105+00, looking northwest

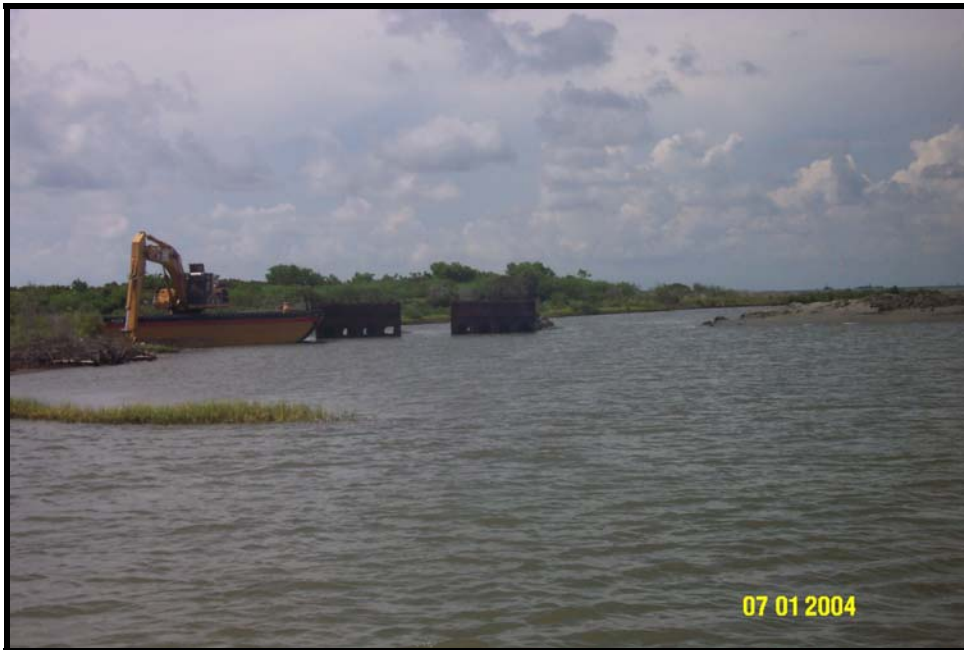
Photo 26. View of overflow weir boxes and construction of back dike at appx. Sta. 105+00, looking north

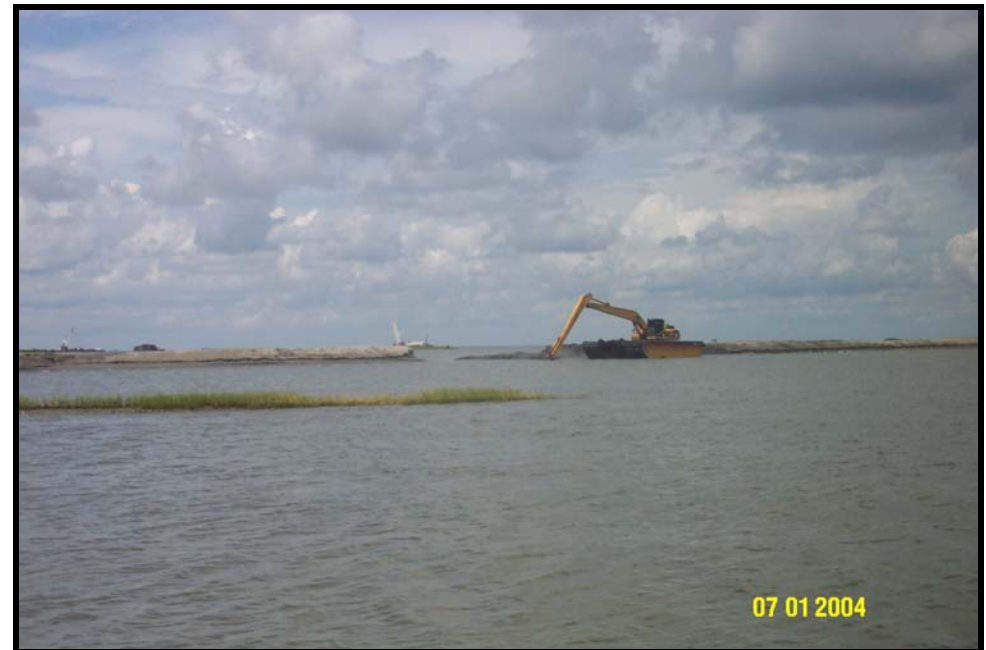
Photo 28. Construction of back dike at appx. Sta. 106+00, looking northeast

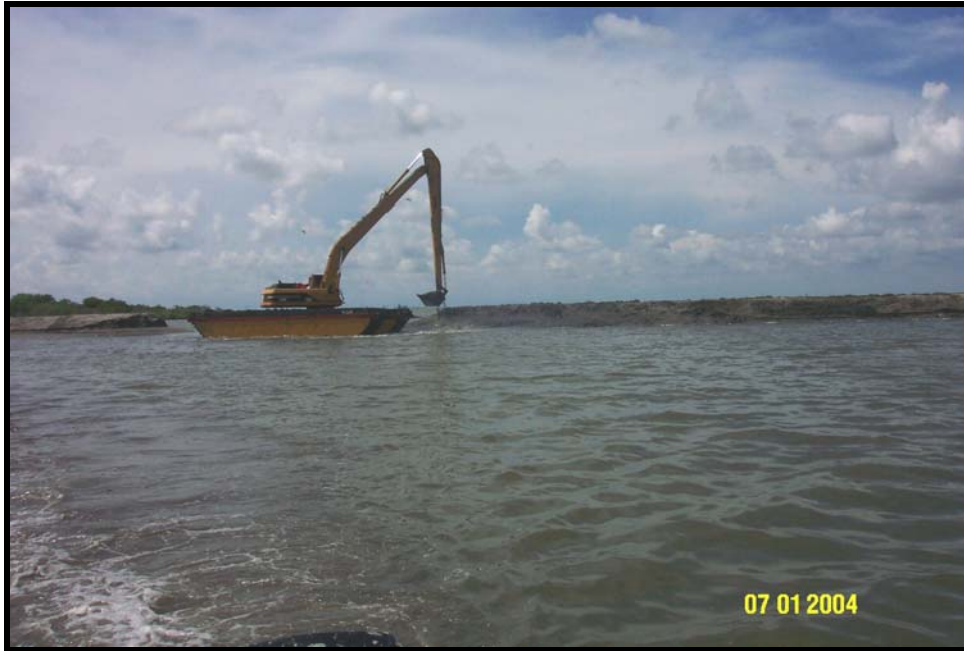
Photo 29. Construction of back dike at appx. Sta. 106+00, looking north

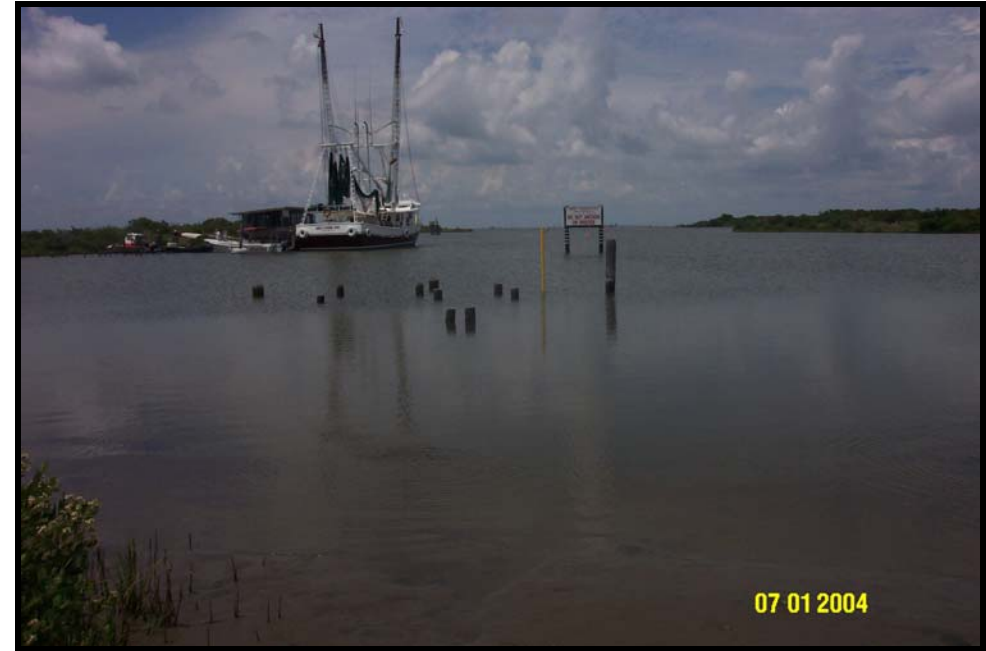
Photo 31. View of Canal No. 19 at Sta. 93+00, standing at south end of canal at approximate location of front (Gulf side) of proposed dune looking north

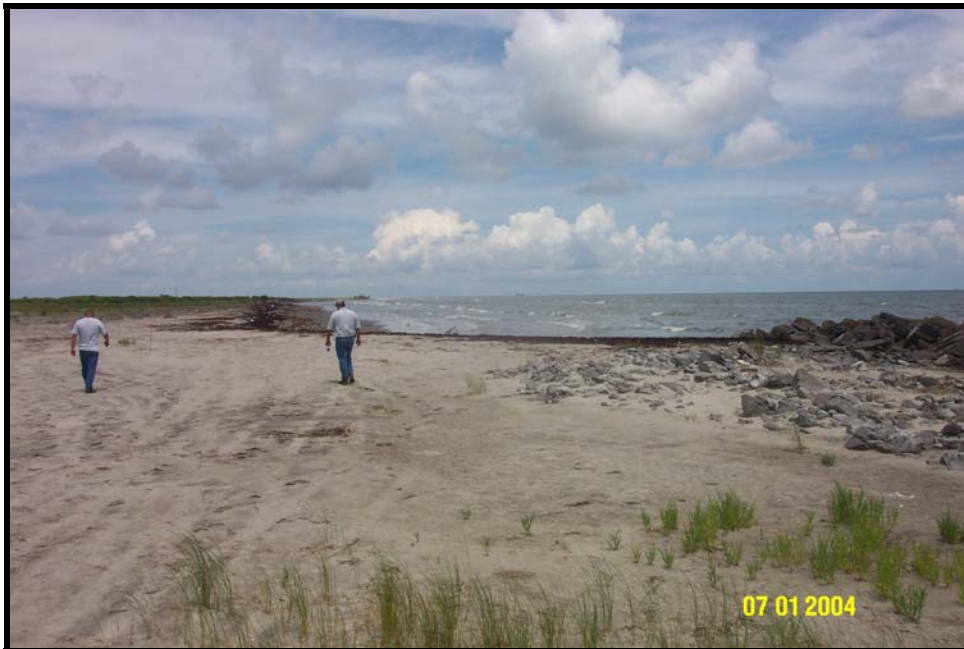
Photo 30. View of Timbalier shoreline at east end of existing rock shoreline protection (Sta. 100+00), looking east

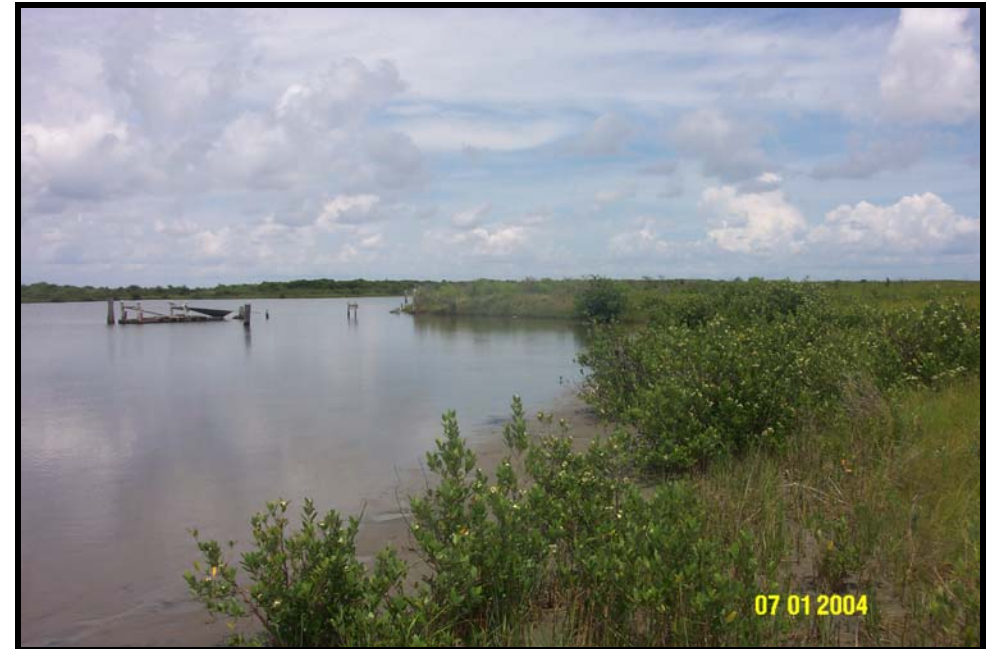
Photo 32. Sta. 93+00, standing at south end of Canal No. 19 at approximate location of front (Gulf side) of proposed dune looking east
